COAL CAR HISTORIC RECONSTRUCTION

The Load-Bearing End Anomaly is Remedied

June 2, 2008

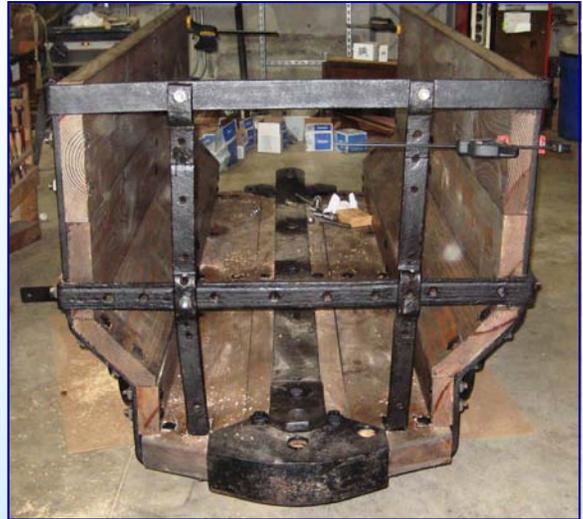
The steel frame of the load end of the coal car.

Previously, we outlined some of the anomalies in the construction of the car and we mentioned that the vertical bars on the load end were put on upside down (see Update for March 10, 2008). This problem has been rectified and the construction of the load-bearing end now makes more sense from an engineering standpoint. It also now matches the way the ends of coal cars look in historic photographs.

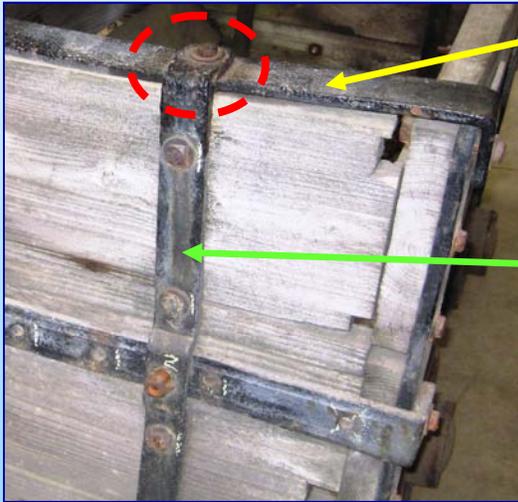
The top bar has been rotated 90° down from the top of the load end onto its side.

The vertical bars have been rotated 180°. The end that was at the top is now at the bottom and vice versa.

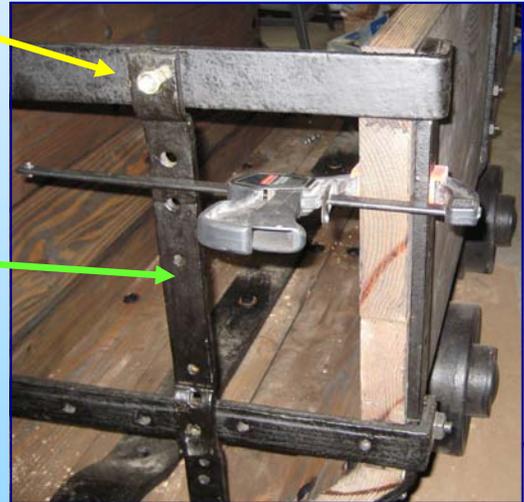
Flipping the vertical bars allows them to be secured to the base with a bolt (see the red dashed circles). This would have been a vital component of the car's ability to haul a ton of coal per load. The way the car was previously put together did not allow for that connection between the vertical bars and the base of the coal car.

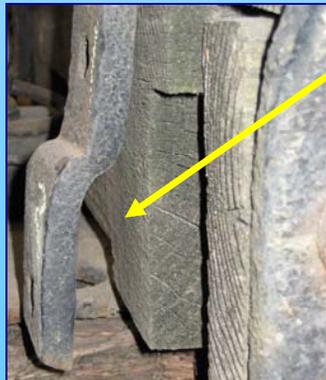
The old base of the vertical bar with no connection to the base of the coal car.

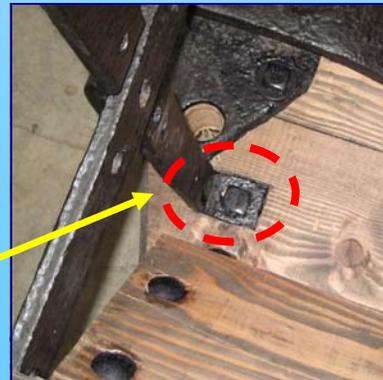
The new base of the vertical bar bolted to the base of the coal car.
